TAT ACTIVITIES REPORT
PRELIMINARY SITE ASSESSMENT
STANDARD STEEL AND METALS SALVAGE YARD
ANCHORAGE, ALASKA

28 OCTOBER - 8 NOVEMBER 1985

Prepared by
Region X
Technical Assistance Team
TDD #10-8510-07

For
Region X
Environmental Protection Agency

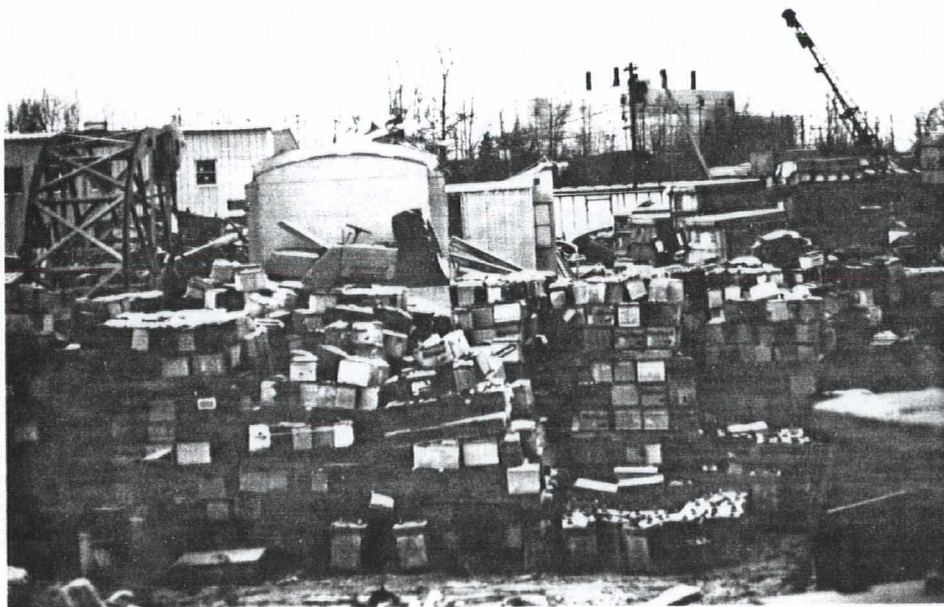
Photo 5. It is estimated that over 20,000 batteries are located on the site, and many are leaking. Several piles as large as this are located throughout the site.

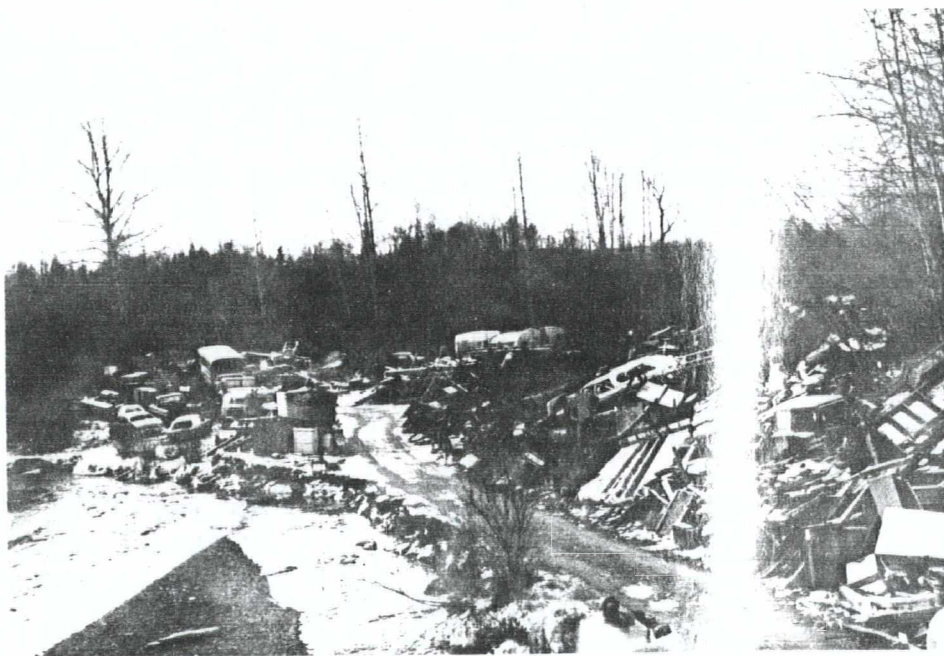
Photo 6. Ship Creek follows the southern border of the site. Metal debris is piled to the edge of the creek bank, and several pieces of metal can be seen in the creek itself. A Standard Steel employee resides in the white trailer in the background.

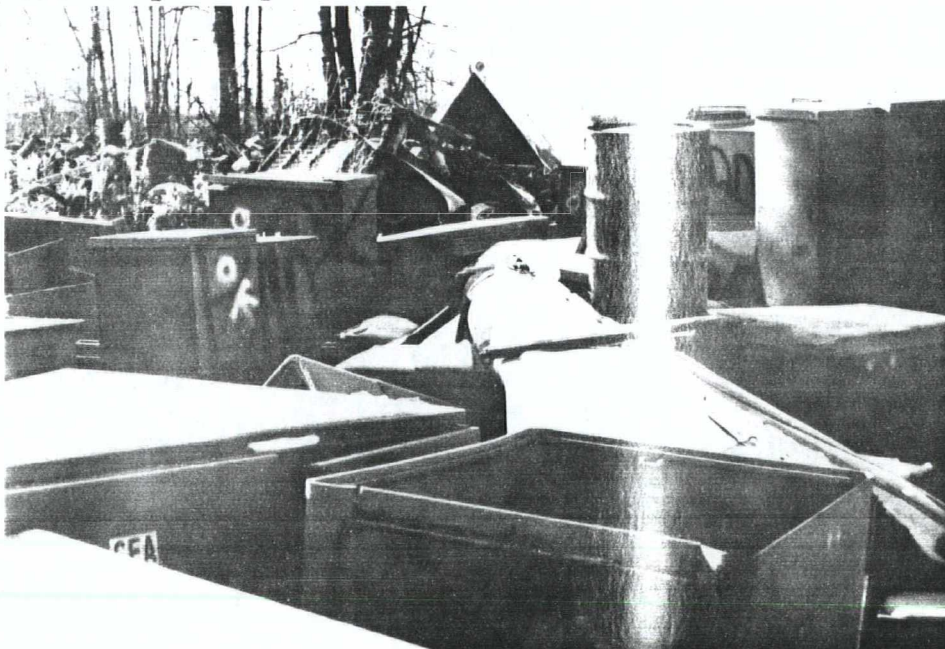
Photo 8. The main transformer storage area. Transformers marked with an "OK" were previously tested by ADEC personnel and were determined to contain less than 50 ppm PCB.

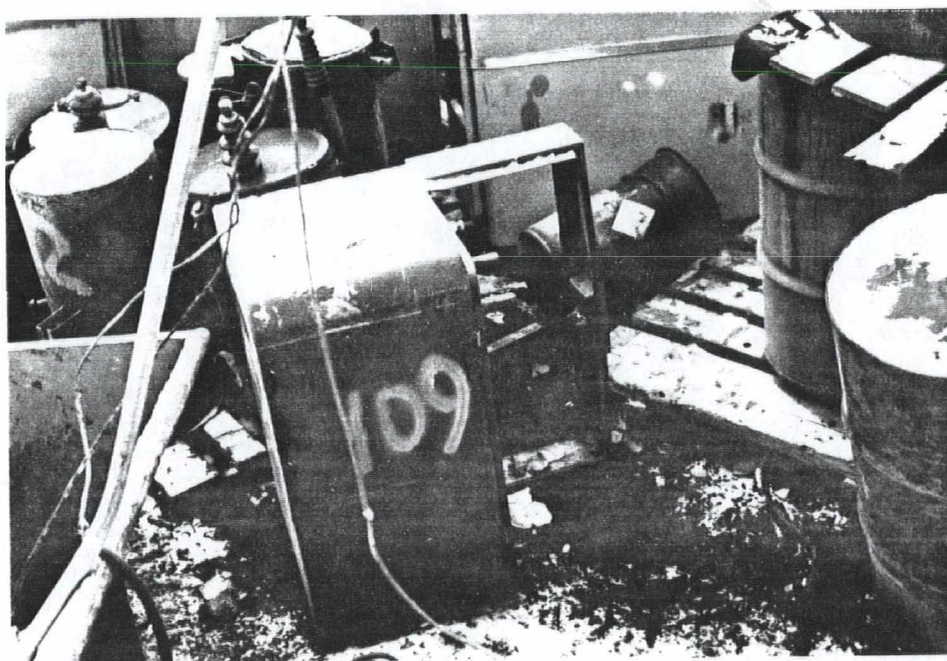
Photo 9. Oil-stained soil in the main transformer storage area. This particular transformer was empty at the time of the assessment. Its contents may have drained into the soil.

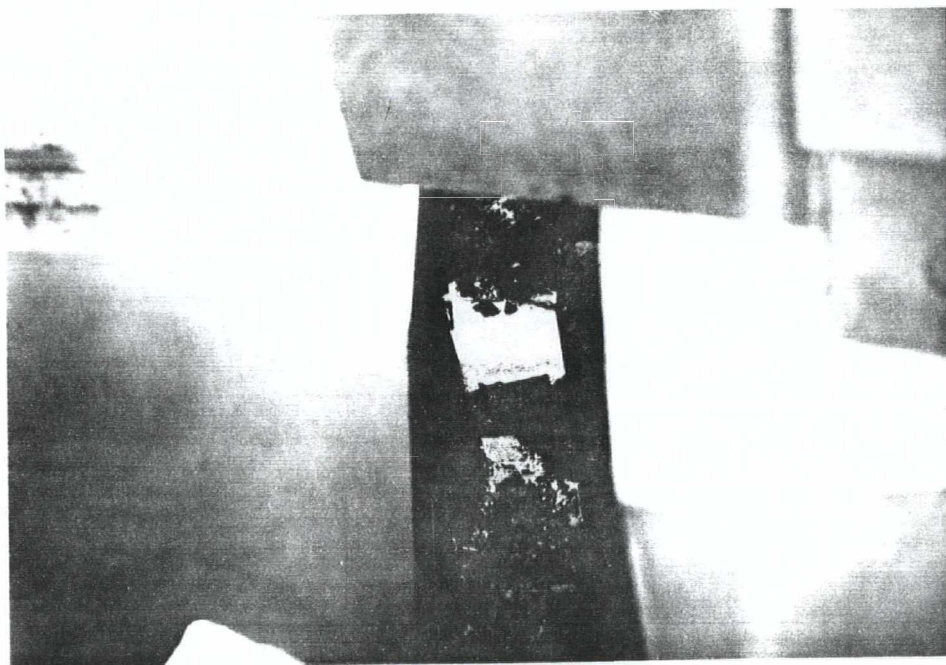
- o Transformer storage area #1 indicated significant PCB contamination. Values ranged from 87.0 to 165,000 ppm. The 165,000 ppm sample was collected from the same area as the 110,000 ppm soil sample ADEC collected on 5 August 1985. The areal surface of this transformer storage area is approximately 100 feet by 100 feet. It is unknown as to what depth contamination has migrated into the soil. It should be noted that a shallow aquifer is reported to exist at approximately 15 feet below the ground surface.

Photo 10. Oil on the ground in the main transformer storage area.

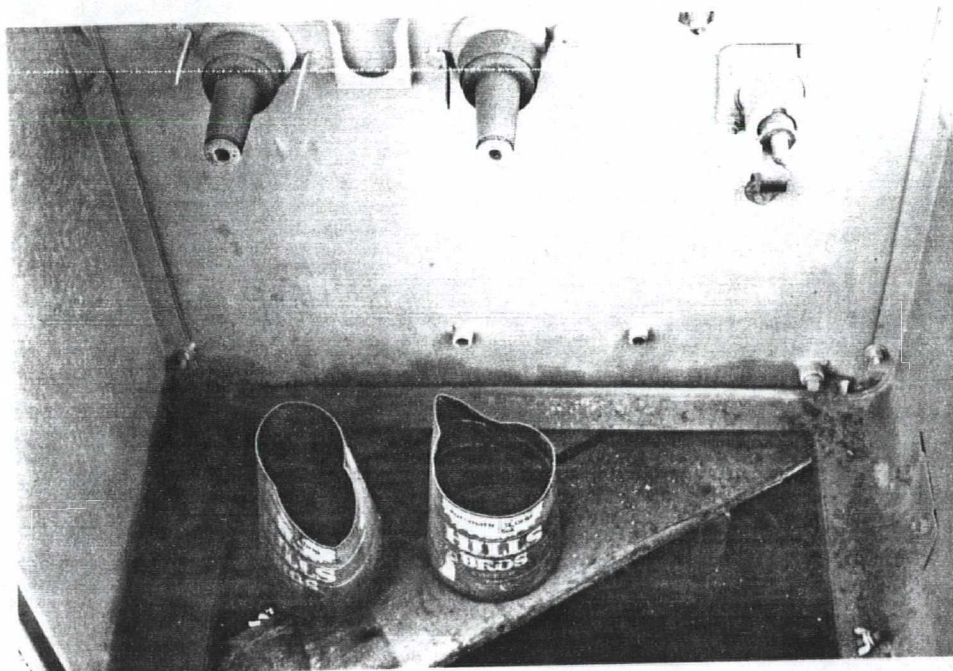
Photo 13. Evidence found in the main transformer storage area which may support the reports that transformer oil was used for lubrication or fire ignition.

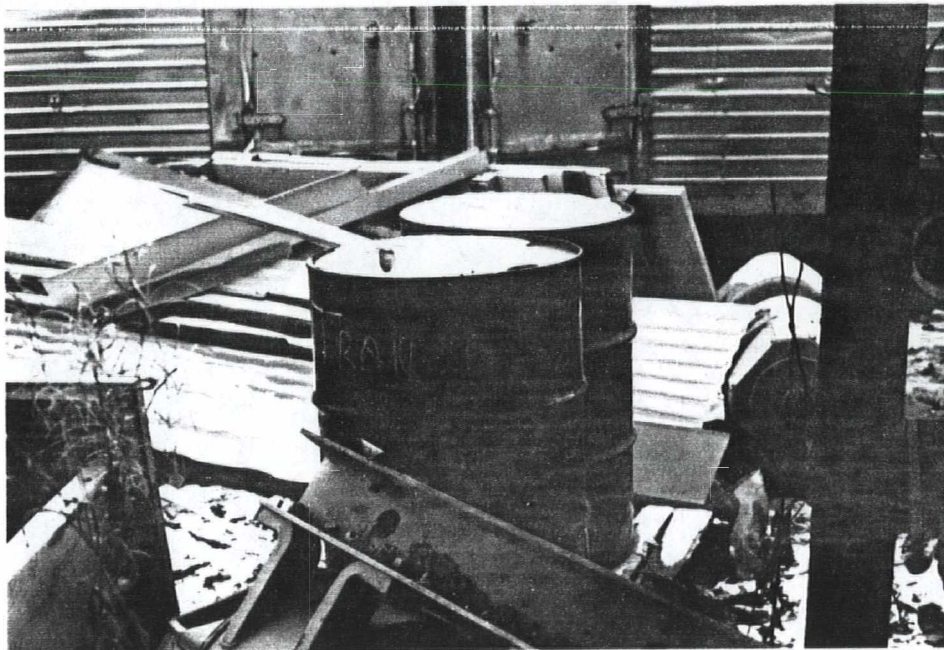
Photo 15. Drums labelled "Transformer Oil" were located in the main transformer storage area. These particular drums did not contain significant PCB contamination.

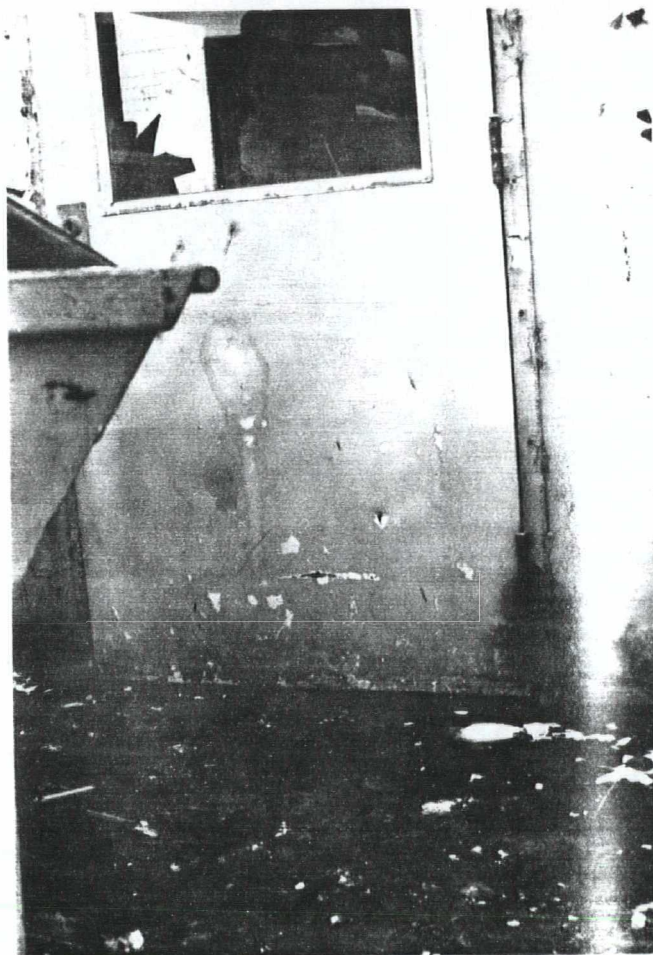
- o The floor of the hydraulic metal crusher building indicated 136 ppm PCB. Samples collected by EPA personnel from this same location previously indicated 20 and 407 ppm PCB. The approximate dimensions of the building floor are 10 feet by 10 feet.
- o Both transformer storage areas #1 and #2 indicated lead, chromium, zinc, copper, and some cyanide contamination. High concentrations of carrier solvents were also observed. These results are provided in Attachment D.

Photo 16. Oil-stained soil in front of the door to the hydraulic metal crusher.

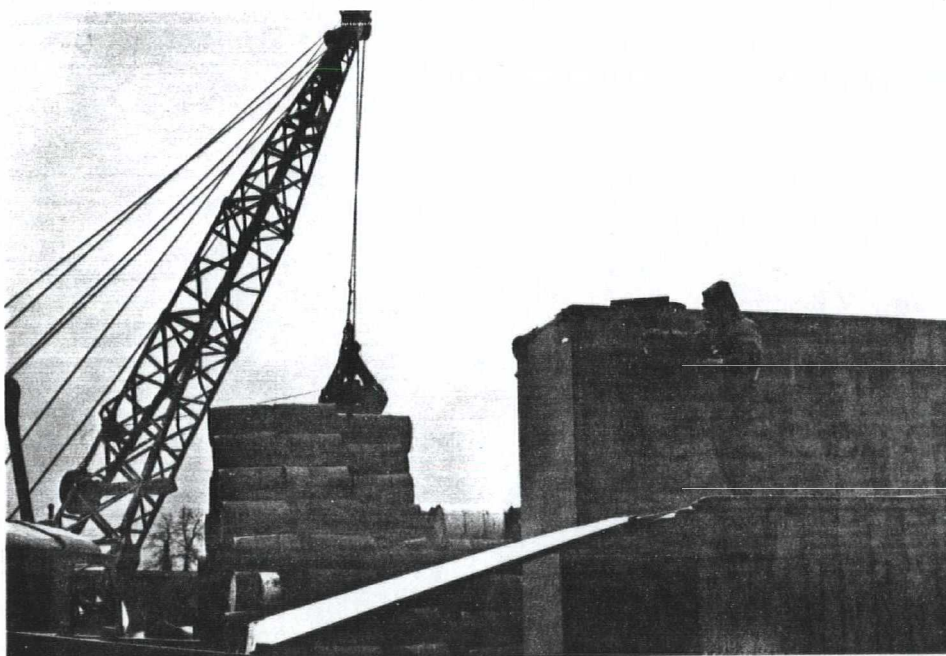
- o Transformer Storage Area #3 - A third transformer storage area, also unknown to EPA and ADEC personnel, was located in the area of the large bulk tank (Figure 2). Fourteen transformers were located in this area, 11 of which were found to be empty. The surrounding soil was again very dark and oil stained. In addition, this area contained charred trans-

Photo 17. Bulk tank #1. Tank contents did not reveal any significant PCB contamination. Transformer storage area #3 is located at the base of this tank.

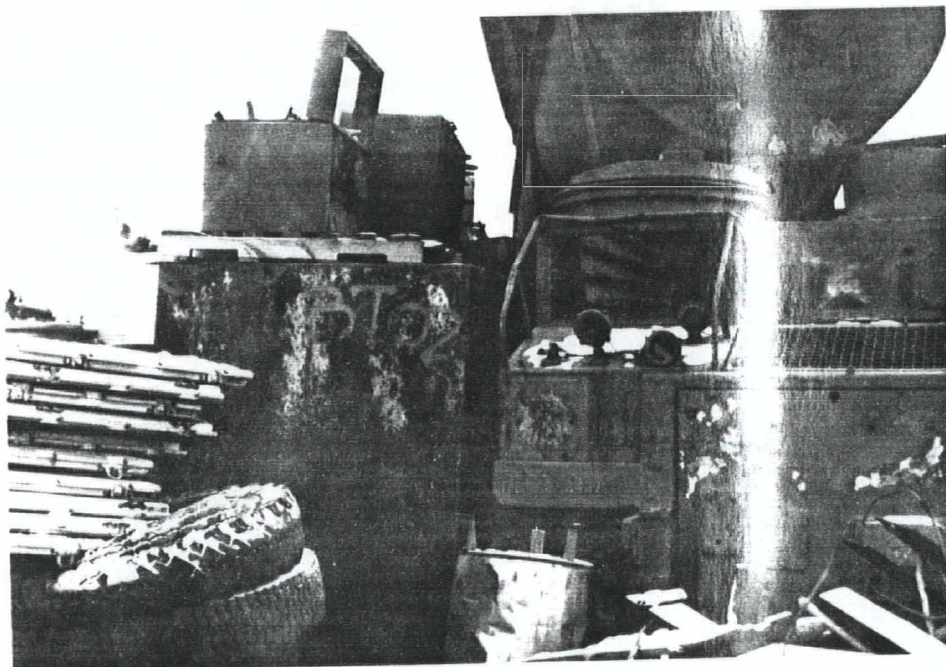
On 5 August 1985, soil samples were collected by ADEC personnel from a stained area of the site where transformers were reportedly dismantled. There was also evidence that some of these transformers were vandalized. Laboratory analyses indicated the presence of 110,000 and 87,000 ppm PCB. Another soil sample collected from the same area by EPA personnel on 23 August indicated 36,000 ppm PCB.

Photo 18. Bulk tank #2. Transformer storage area #2 is also located here. Soil collected just to the left of the pile of tires indicated 36,000 ppm PCB.

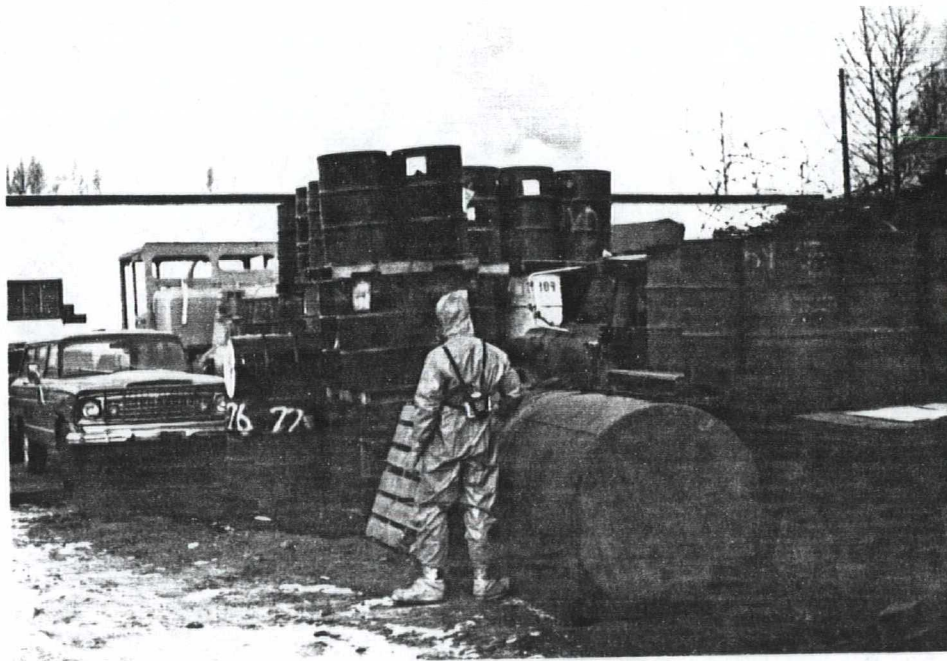
Photo 19. Bulk tank #3. Contents did not reveal any significant PCB contamination. Stained soil can be seen near the drum stacks in the background.

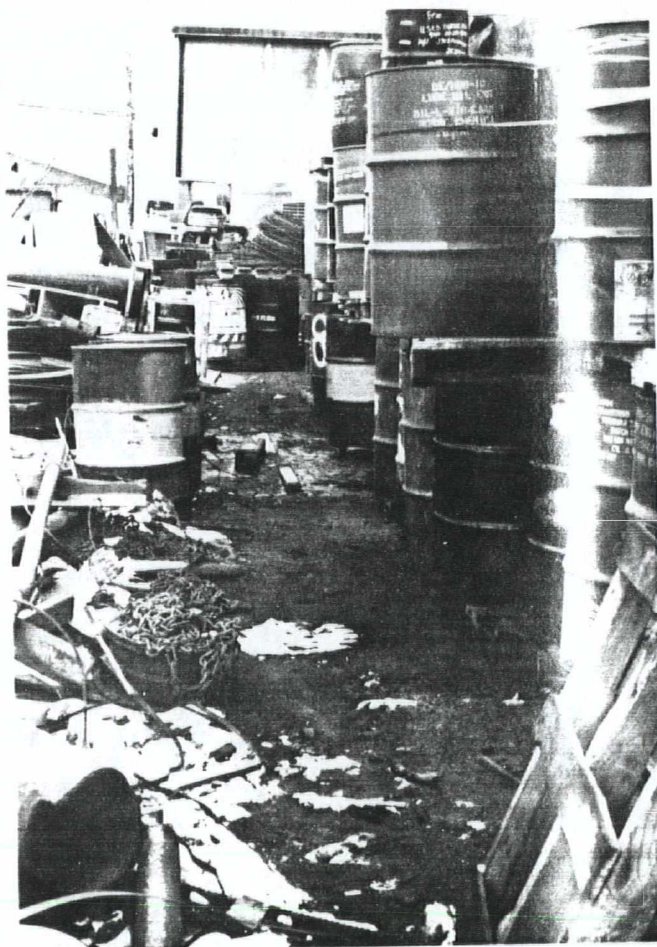
Photo 20. Over 700 drums are located on the site. Several of these drums are in poor condition and many are leaking.

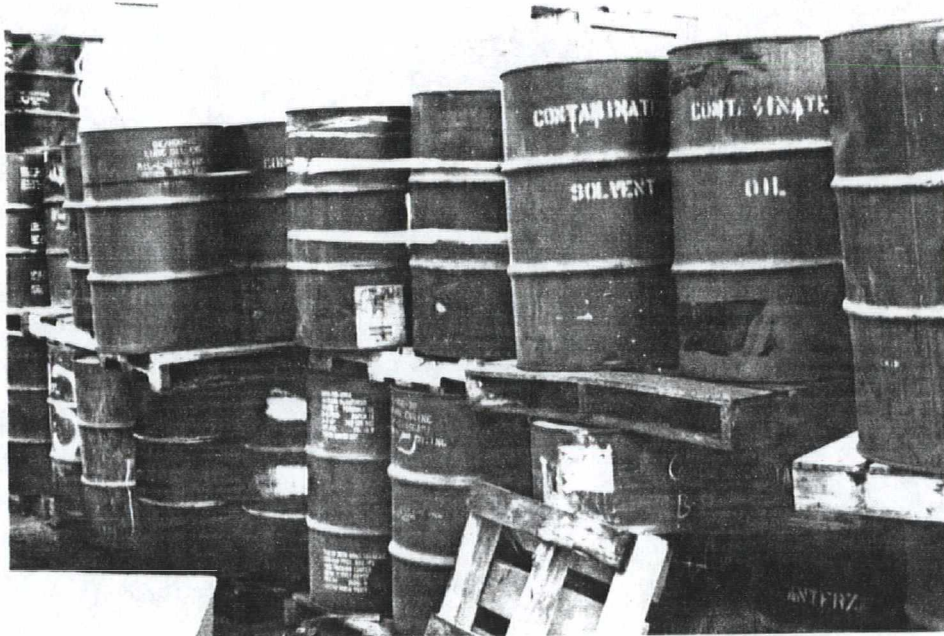
Photo 21. Several drums displayed labels or other identifying marks. No records were maintained by Standard Steel concerning the source of the drums.

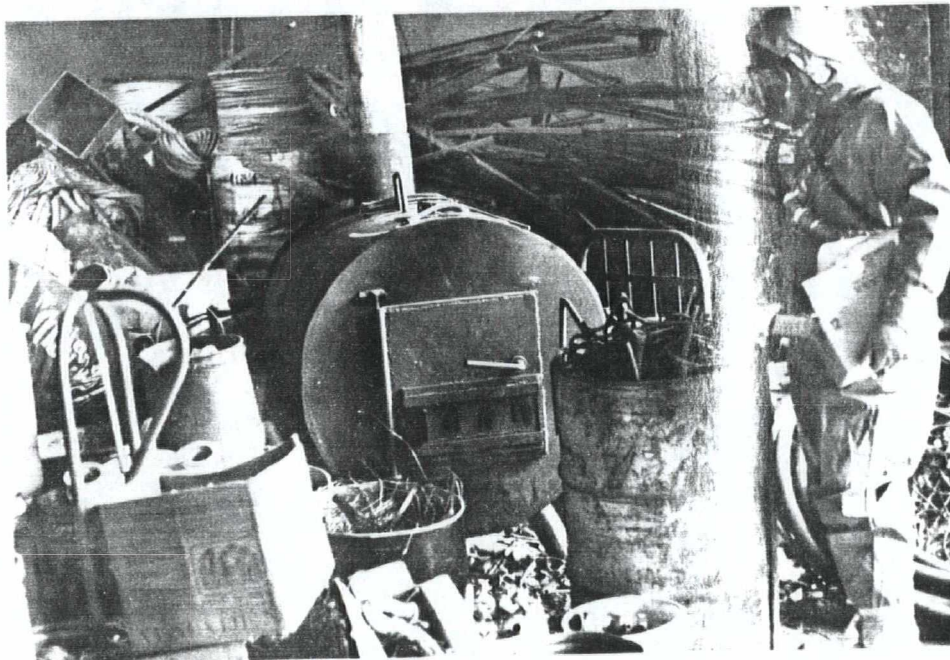
Significant levels of chlorinated dioxins and furans were present in all samples, suggesting that the burning of transformer oil did occur at the Standard Steel site. Studies have indicated that the combustion of PCB oil forms chlorinated dioxin in the ppb range and chlorinated furans in the ppm range. Although ppm levels of furans were not indicated, they were present in concentrations up to ten times greater than the corresponding dioxin isomer. Further information on the combustion of PCB transformer oil and the toxicity of the combustion products is provided in the Toxicity of Contaminants section of this report.

Photo 22. The incinerator which was reportedly utilized to burn transformer cores.

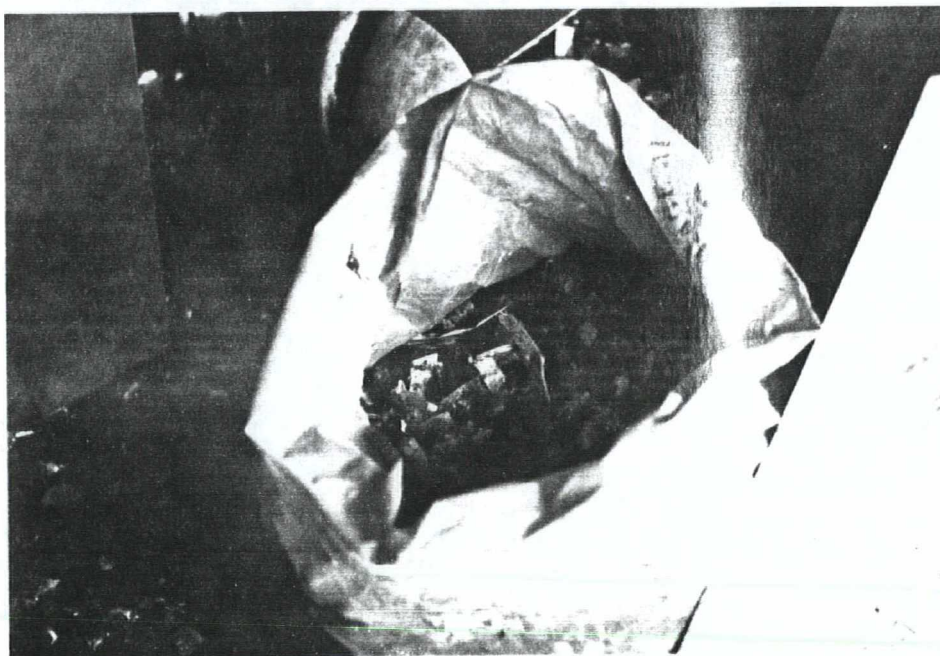
Photo 24. Ash from inside the incinerator.

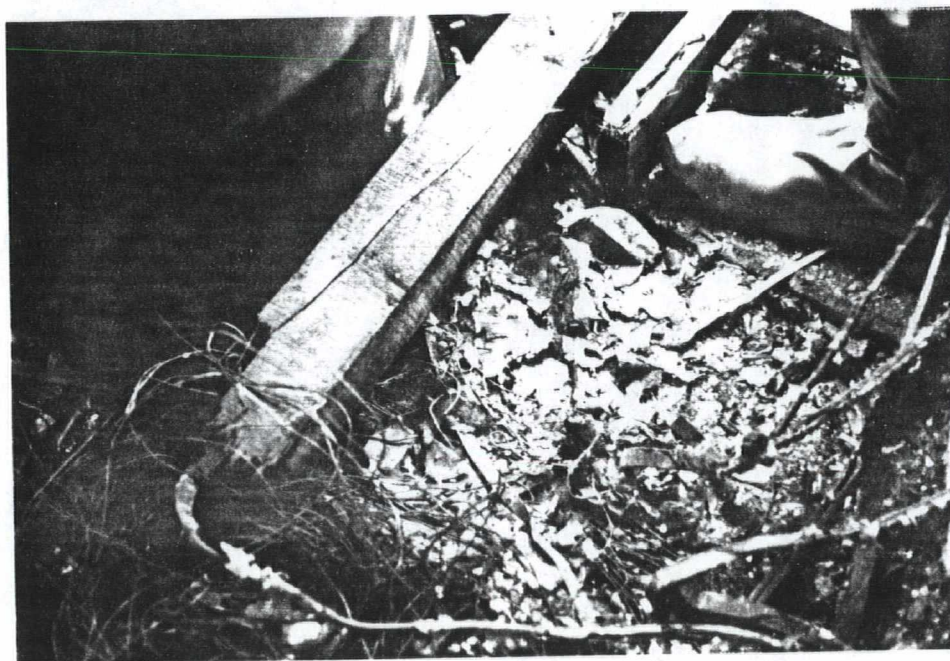
Photo 25. Ash on the floor in the vicinity of the incinerator. Ash piles were located in several areas throughout the site.
